UNITED STATES COAST GUARD
U.S. Department of Homeland Security

MARINE SAFETY ALERT
Inspections and Compliance Directorate

Safety Alert 13-18

Let us enlighten you about LED lighting!
Potential interference of VHF-FM Radio and AIS Reception.

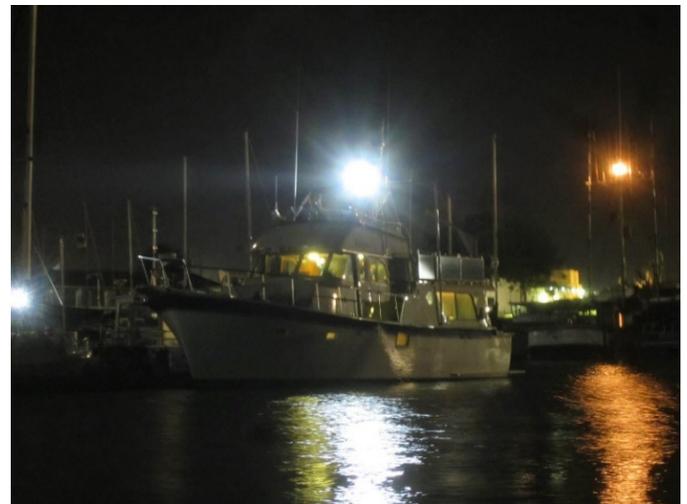
The U.S. Coast Guard has received reports from crews, ship owners, inspectors and other mariners regarding poor reception on VHF frequencies used for radiotelephone, digital selective calling (DSC) and automatic identification systems (AIS) when in the vicinity of light emitting diode (LED) lighting on-board ships (e.g., navigation lights, searchlights and floodlights, interior and exterior lights, adornment).

Radio frequency interference caused by these LED lamps were found to create potential safety hazards. For example, the maritime rescue coordination center in one port was unable to contact a ship involved in a traffic separation scheme incident by VHF radio. That ship also experienced very poor AIS reception. Other ships in different ports have experienced degradation of the VHF receivers, including AIS, caused by their LED navigation lights. LED lighting installed near VHF antennas has also shown to compound the reception.

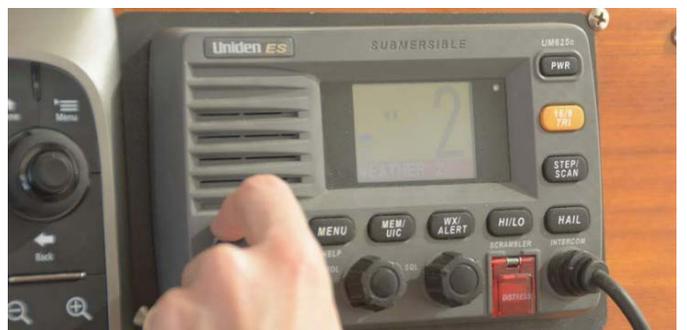
5. Turn on the LED light(s).
 - If the radio now outputs audio noise, then the LED lights have raised the noise floor. (Noise floor is generally the amount of interfering signals / static received beyond the specific signal or channel being monitored.)
6. If the radio does not output audio noise, then the LED lights have not raised the noise floor.

If the noise floor is found to have been raised, then it is likely that both shipboard VHF marine radio and AIS reception are being degraded by LED lighting.

1. Turn off LED light(s).
2. Tune the VHF radio to a quiet channel (e.g. Ch. 13).
3. Adjust the VHF radio's squelch control until the radio outputs audio noise.
4. Re-adjust the VHF radio's squelch control until the audio noise is quiet, only slightly above the noise threshold.
